## Report: The Lake Merritt Pergola

The Pergola consists of three loggias and two pergolas: a large central loggia flanked by a smaller loggia on either side. The loggias are connected by two arms of a curved trellis covered pergola walkway that embraces the end of this arm of the lake. The structure is 200 ft long, with 21ft x 21 ft end loggias, and the 50 ft x 28 ft central Loggia (Oakland Tribune, 2/15/1914).

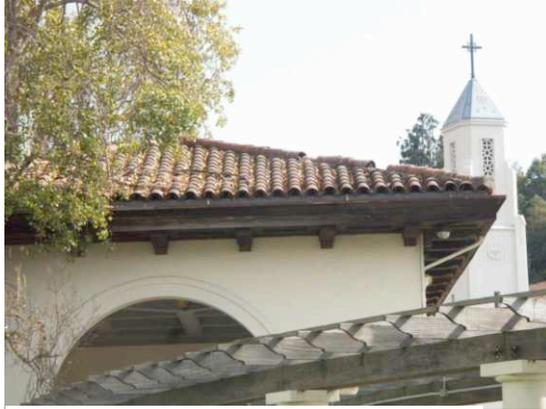
*Main loggia with missing hip tiles.*

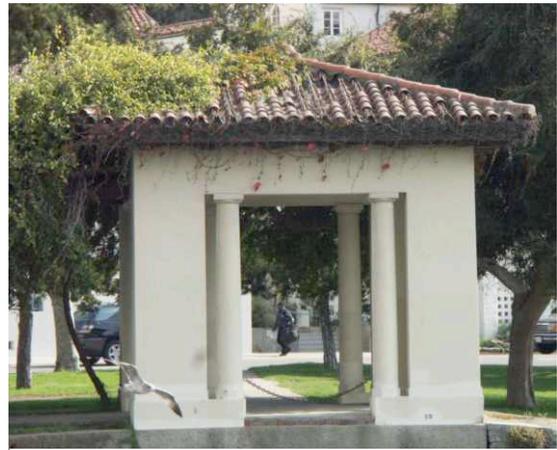
*South loggia showing missing roof tiles and potential damage from vines.*

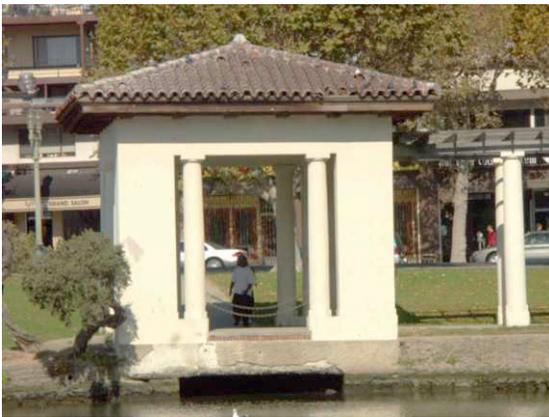
*Small loggia on North side, showing missing roof tiles and stream outlet below floor.*

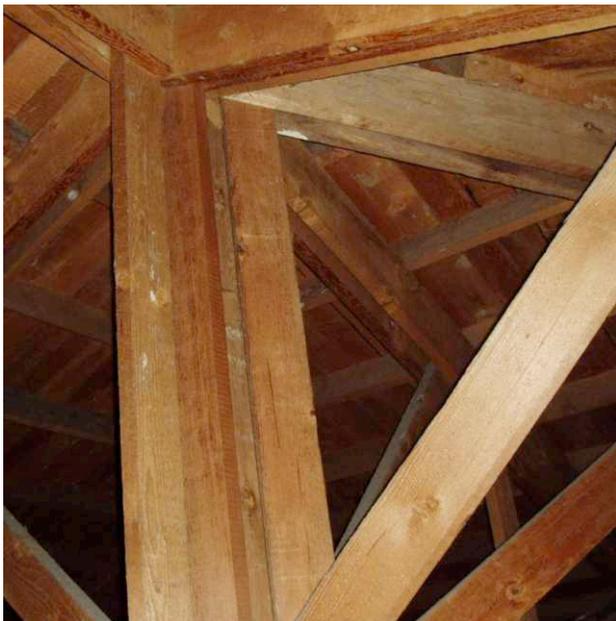
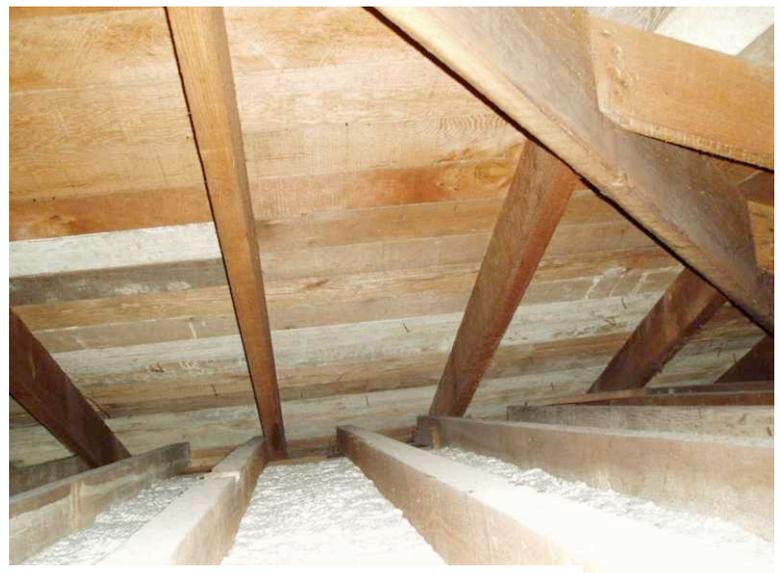
We expected to find a lot of damage in the concealed attic spaces of the three loggias. However, to our surprise the interior of the attics revealed little to no wood rot or damage, and not even staining from water intrusion. The boards in the attics appear to be original, from 1913, with small knots and tight, old-growth grain. Some of the straight sheathing boards were

*Attic of main loggia at left; small loggia attic above.*

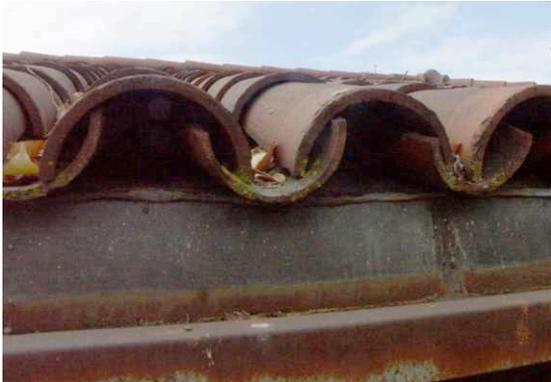
*2-piece tapered mission tiles are 9 1/8" wide x 18" long. The profile is a full half circle. The wide end of the cover tiles and the narrow end of the pan tiles are visible in this photo.*

The existing roof tiles are tapered mission style, 9 1/8" wide, 4 1/2" high, 18" long, and 1/2" thick, with a full half-circle (180°) profile. The tiles are installed across the roof in straight rows, with the horizontal joints of each tile aligned. Each tile has one hole near the top end for attaching it to the roof with a nail or a wire.

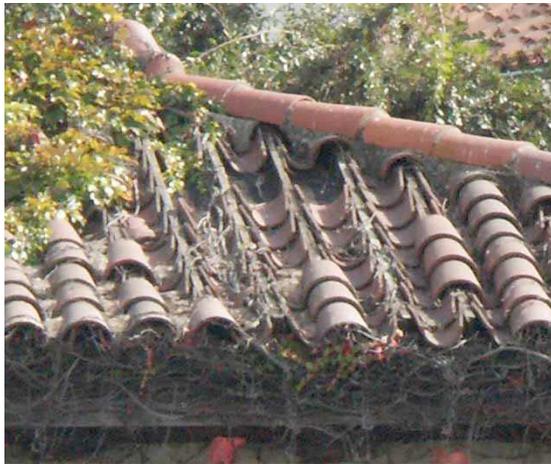
*Above: approximately 50 missing cover tiles on the South loggia leave pan tiles exposed. Wood battens are visible between columns of pan tiles.*

*Below: ridge cover tiles and special cap tile on main loggia. Apex tile is visible at the top.*

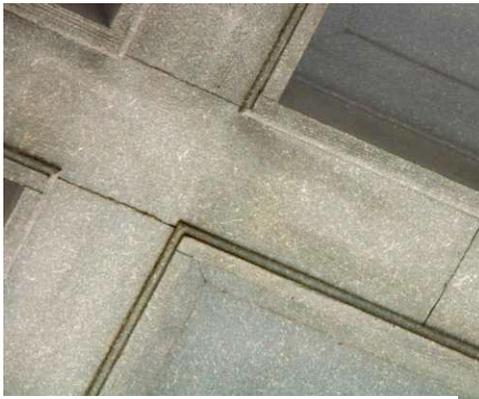
*Zolatone ceiling paint detail*

The plaster and wood ceilings are currently painted with a multi-color grey and white speckled paint (Zolatone). This finish was invented in the 1940's. It is our guess that the paint was applied in 1961, when the work on the floors was done. The historic photographs show the original coffered ceiling in the main loggia with contrasting light and dark colors. We assume that the wood was originally unpainted (currently grain wear can be observed under the paint of the coffers), while the plaster panels between were originally either integrally colored or painted in a light color.

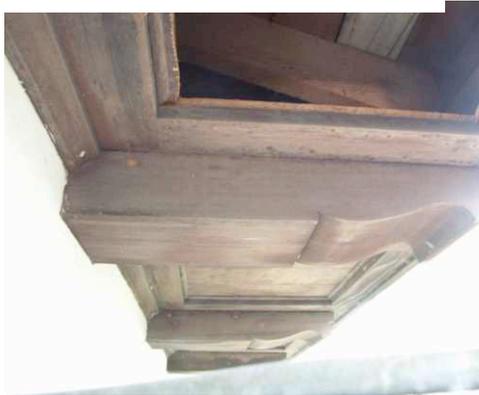
*Unpainted redwood soffit in excellent condition on the North loggia.*

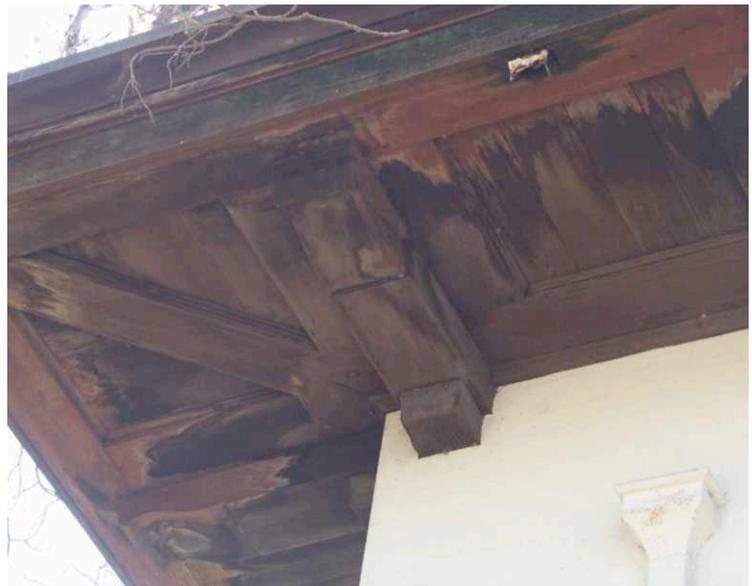
The small loggias have no gutters or downspouts. The main loggia has flat sheet metal gutters, which show a significant amount of rust and should be replaced. The gutters are concealed above a redwood gutter and lead to four downspouts. One downspout is disconnected from the gutter on the central building.

The unpainted redwood soffits are in good to excellent condition in most areas, although the corner of the main loggia with the missing downspout shows some water damage. The fact that the wood was unpainted may have helped the whole attic to dry after any moisture was introduced.

*Stained soffit and missing downspout at SE corner of main loggia.*

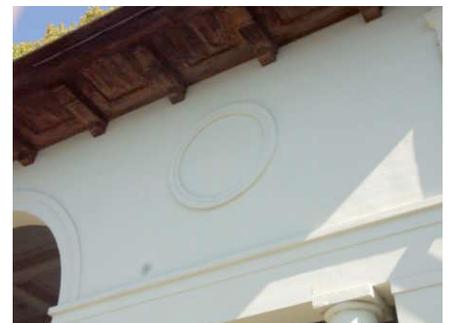
There are round medallions on two sides of the main loggia, which are currently painted the same white as the walls of the building. Historic photos show a darker color in these circles. There is no evidence in the photos we have found that there was ever a decorative motif inside these circles. However, the two circles that face El Embarcadero currently are covered with metal panels that are painted white. The panels are held in place with four protruding nails. We did not remove a panel to see what is behind it. Further investigation is needed.

*Round medallions on main loggia are currently painted white.*

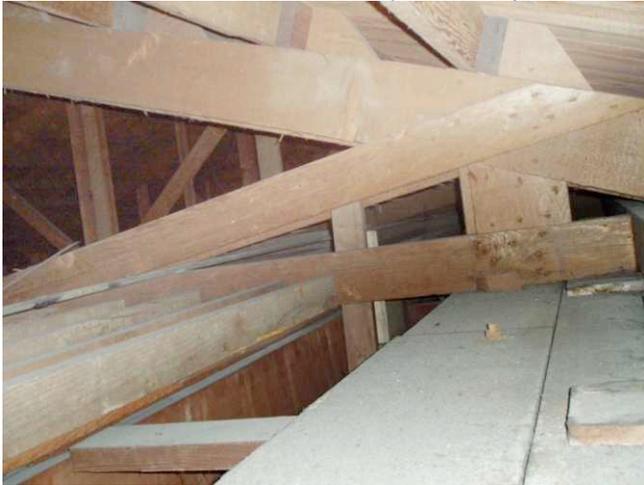
*Attic of main loggia, showing sill plate bolted to concrete wall, but no shear connection between plate and roof.*

(1) Main Loggia: The wood roof diaphragm and the connection of the roof to the concrete walls are seriously deficient. The roof has straight sheathing that is very flexible because of the weight of the heavy Spanish roof tile. It is very weakly connected to the walls in shear and also lacks adequate anchorage to the walls in tension. The concrete walls were found to have sufficient strength in shear, but are very lightly reinforced and therefore damageable. It is not expected, however, that these will collapse in the design earthquake, although they could experience cracking.

We recommend improvements in the connection between the roof and the walls of the structures. This could be done with wooden stud framing and plywood sheathing, or an alternate form of bracing. The bracing is best installed while the roofing is off, so that access to the connections can be made through the roof.

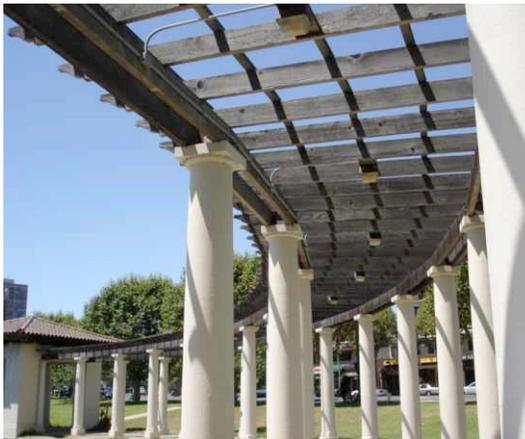
The central loggia and two outer loggias each have a single light fixture at center of their ceilings. The original historic light fixtures have been replaced with vandal resistant types using high pressure sodium lamps. Electrical consultant Ron Zeiger reports seeing two historic fixtures that may be identical to the fixtures shown in the historic photo above the existing ceiling in the boat house. These fixtures could be renovated and moved to the loggia or could be used as a model for new, more historically appropriate fixtures for the loggias.

The original pergolas apparently did not have light fixtures. Presently the pergolas have light fixtures attached to the underside of the trellis, mounted to boards and centered between columns. Conduit is run exposed on the sides of the trellis; a junction box is provided from which another conduit runs to the light fixture. The existing light fixtures are similar to those in the loggias.

*Existing light fixtures in the pergola (top) and small loggia.*

replaced due to basic deterioration and obsolescence. Those in the loggias should be replaced with a more aesthetic fixture to complement the architecture, such as a round style fixture with vandal resistance construction. For the pergolas the fixtures could remain in their present locations, with the exposed conduits and support boards. Alternatively, the existing fixtures and wiring could be removed, and new lights and wiring installed above the trellis making the wiring nearly invisible from below. The new pergola lights could also be a more aesthetic fixture to complement the architecture.

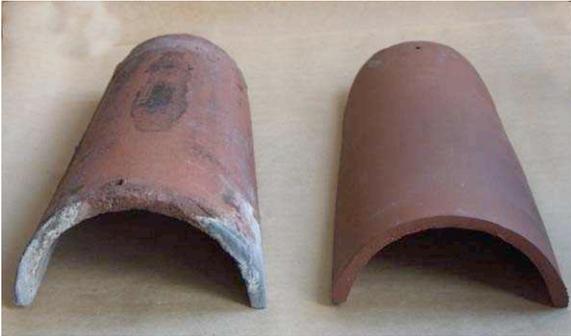
*Historic tile on left. New, less curved tile on right.  
New tile is also thinner and more uniform in texture.*

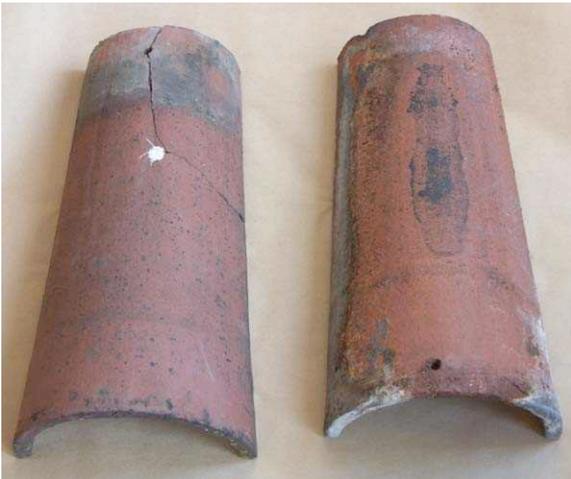
*Historic cover tile on left. Historic pan tile, shown upside-down, on right. Both tiles are identical in shape, but the attachment hole is at the narrow (top) end of the cover tile and the wide (bottom) end of the pan tile. Note tar and mortar stains on the pan tile. These two tiles differ somewhat in texture and color, but further evaluation is needed to determine if this variation is typical of all the tiles.*
