## Report: The Lake Merritt Pergola

The Pergola consists of three loggias and two pergolas: a large central loggia flanked by a smaller loggia on either side. The loggias are connected by two arms of a curved trellis covered pergola walkway that embraces the end of this arm of the lake. The structure is 200 ft long, with 21ft x 21 ft end loggias, and the 50 ft x 28 ft central Loggia (Oakland Tribune, 2/15/1914).

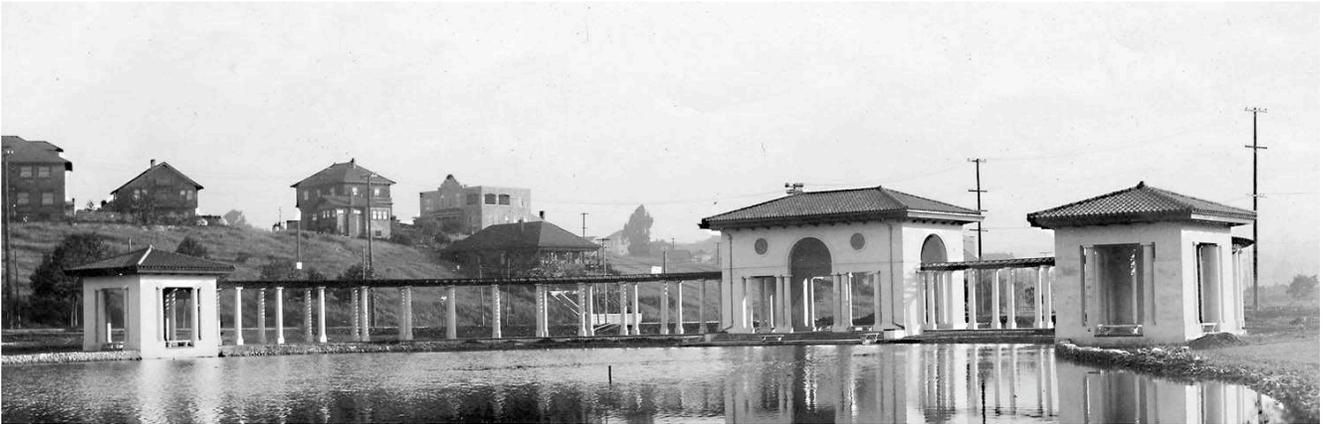
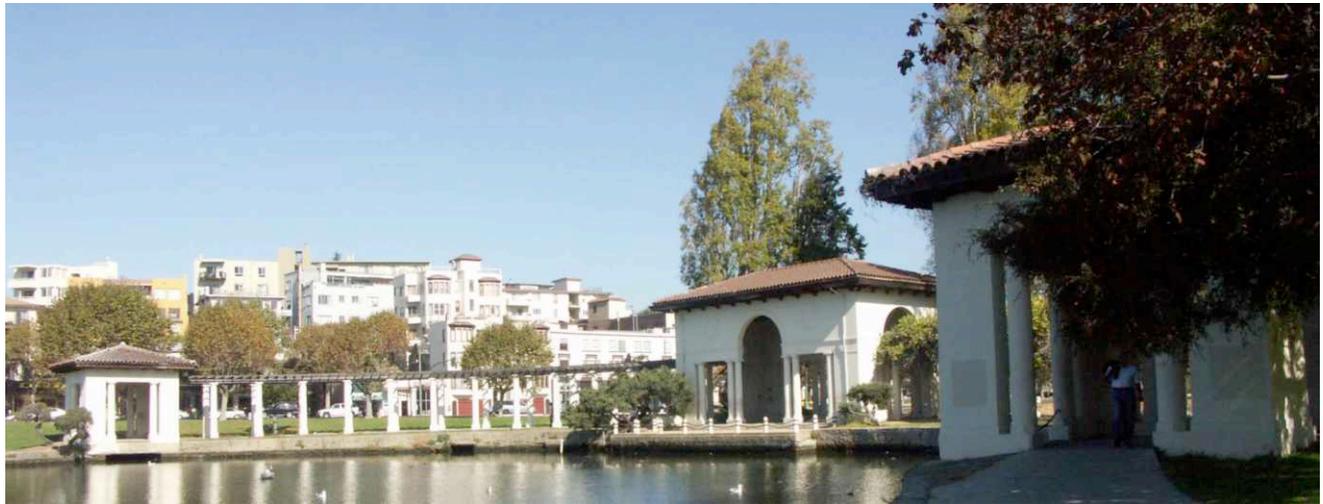
*Current and historic views of structure. Main loggia is in center, South loggia is at right, north loggia across water at left. Curved pergolas join the three loggias.*

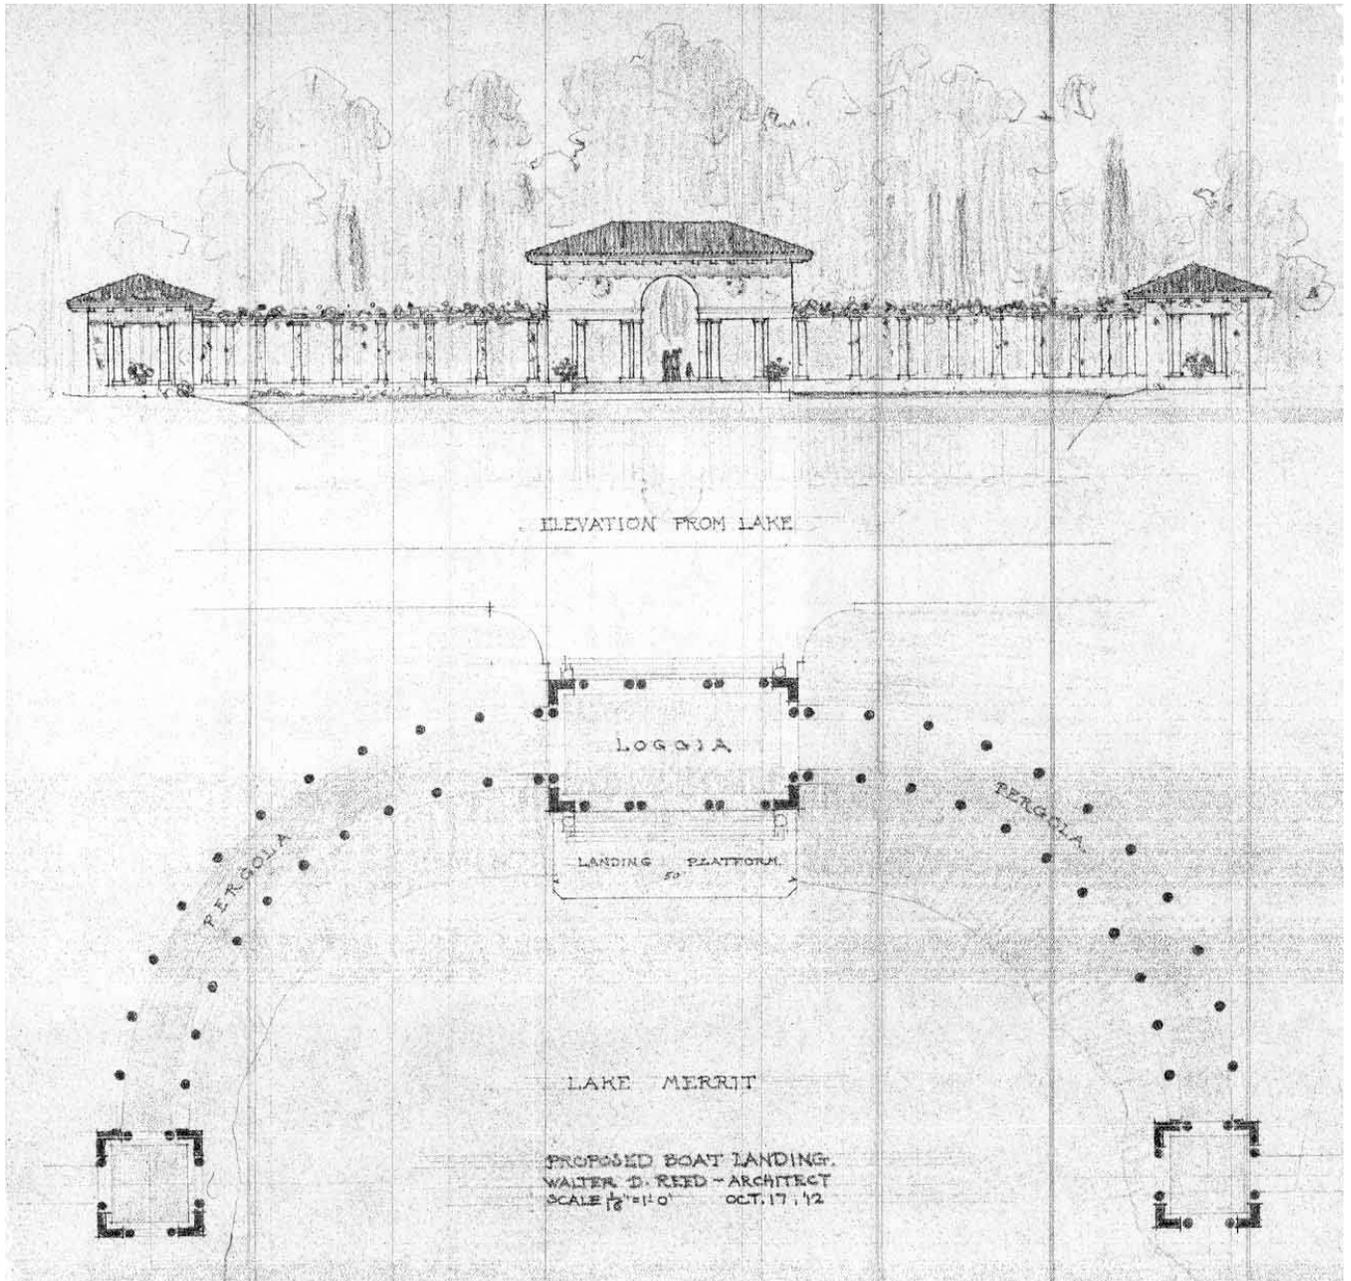
*Original design sketch by Walter Reed, from drawing in Parks and Recreation department files. North is to the left on the plan.*

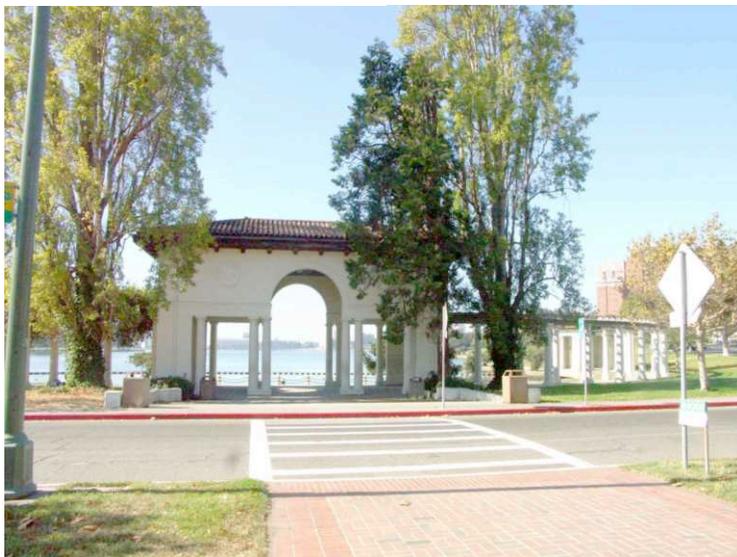
*Main loggia as seen from El Embarcadero Street.*

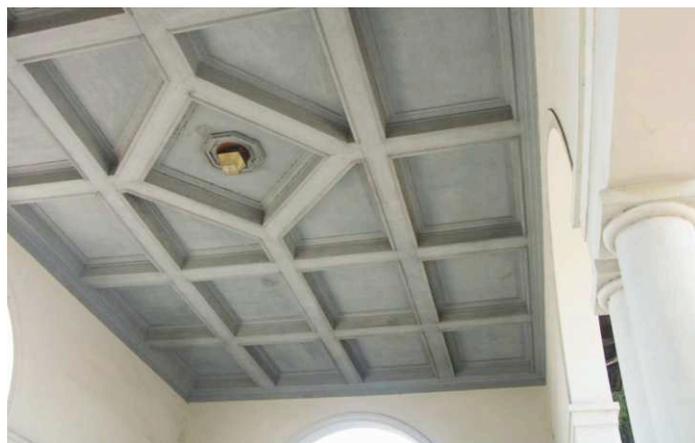
*Coffered ceiling of main loggia.*

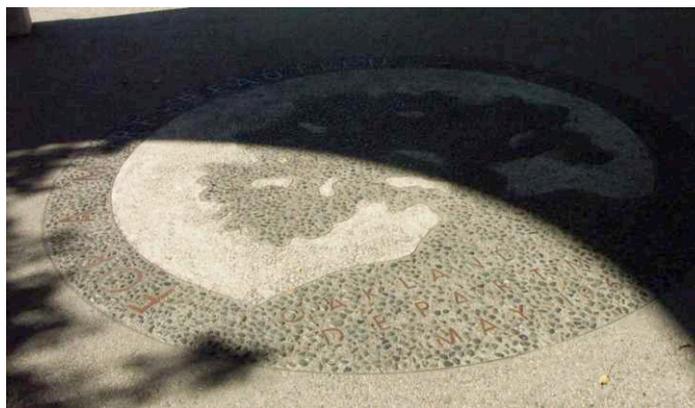
*Circular mosaic in the center of the main loggia.*

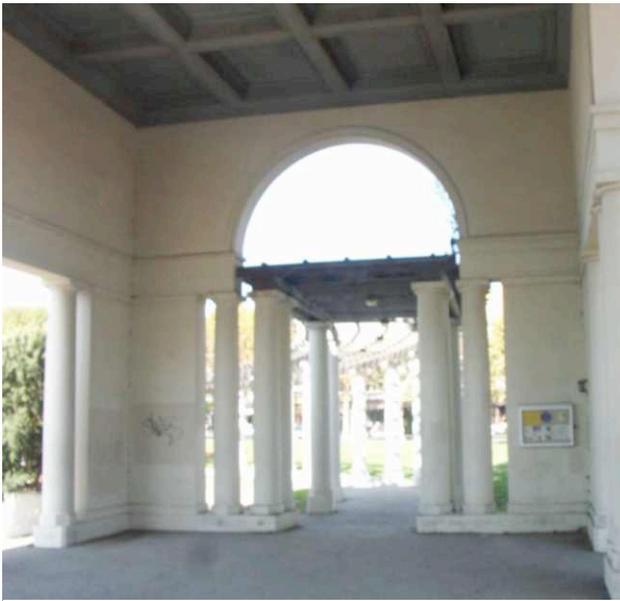
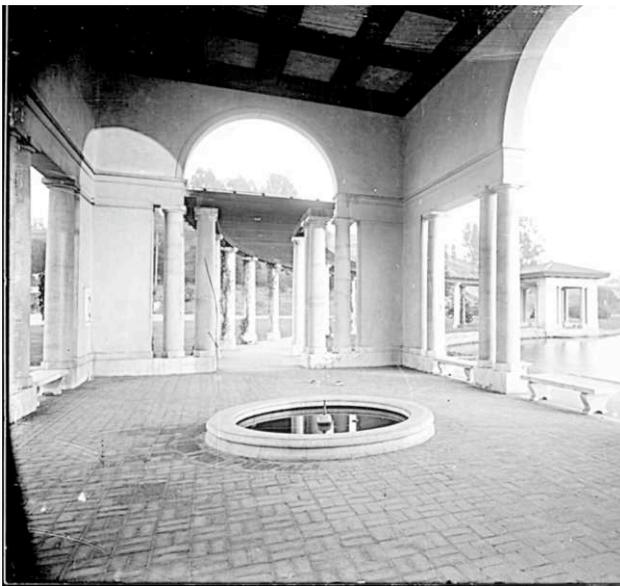
*Above: current photo showing concrete floor, painted ceiling, trellis with vines. Below: historic photo showing brick floor and fountain.*

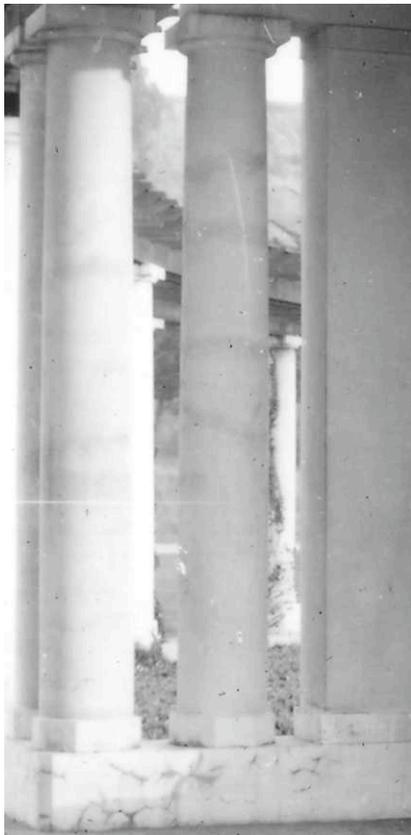
*Enlargement of historic photograph, showing faux marble paint on columns and base of wall.*

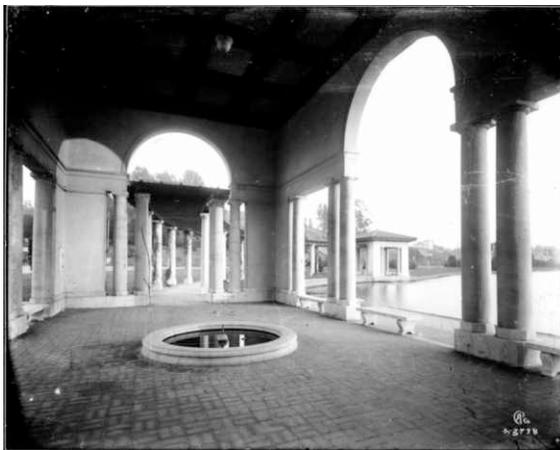
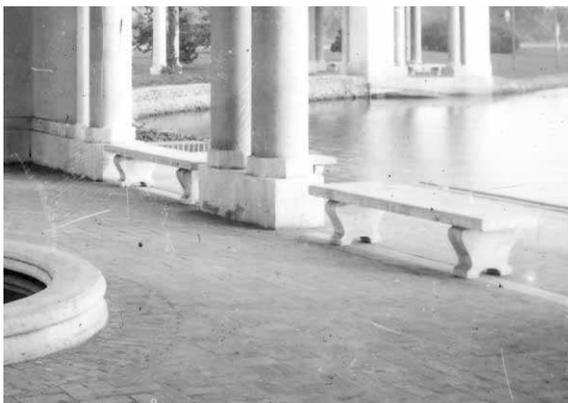
*Historic photos show brick floor and concrete benches.*

*Round medallions on main loggia are currently painted white.*

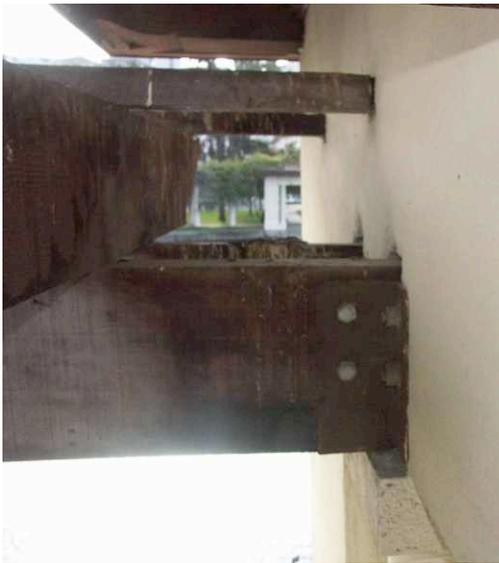
*Bolts connecting north pergola to north small loggia are believed to have been added in 2004 when the trellis was rebuilt.*

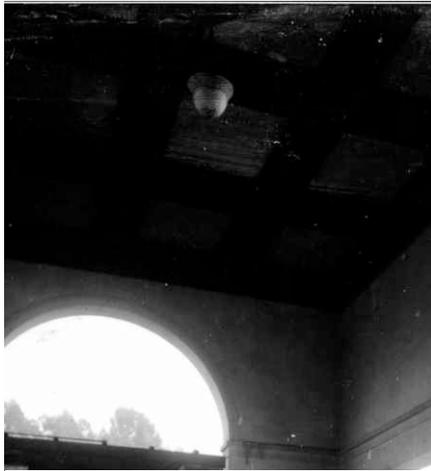
*Historic light fixture is barely visible in this historic photograph of the interior of the main loggia.*

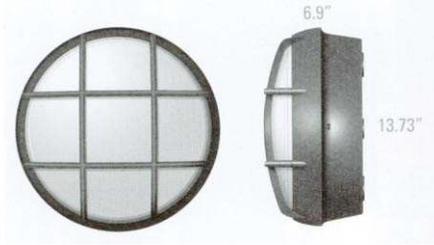
*Modern vandal-resistant fixture. Circular shape blends with historic building.*

replaced due to basic deterioration and obsolescence. Those in the loggias should be replaced with a more aesthetic fixture to complement the architecture, such as a round style fixture with vandal resistance construction. For the pergolas the fixtures could remain in their present locations, with the exposed conduits and support boards. Alternatively, the existing fixtures and wiring could be removed, and new lights and wiring installed above the trellis making the wiring nearly invisible from below. The new pergola lights could also be a more aesthetic fixture to complement the architecture.
